**AN ALL-HAZARDS VULNERABILITY  
ASSESSMENT OF ARTHUR'S PASS TOWNSHIP,  
SOUTH ISLAND, NEW ZEALAND**

A thesis  
submitted in partial fulfilment  
of the requirements for the degree  
of  
Master of Science in Hazards and Disaster Management  
at the  
University of Canterbury  
by  
Kate Dundas

UNIVERSITY OF CANTERBURY

2008

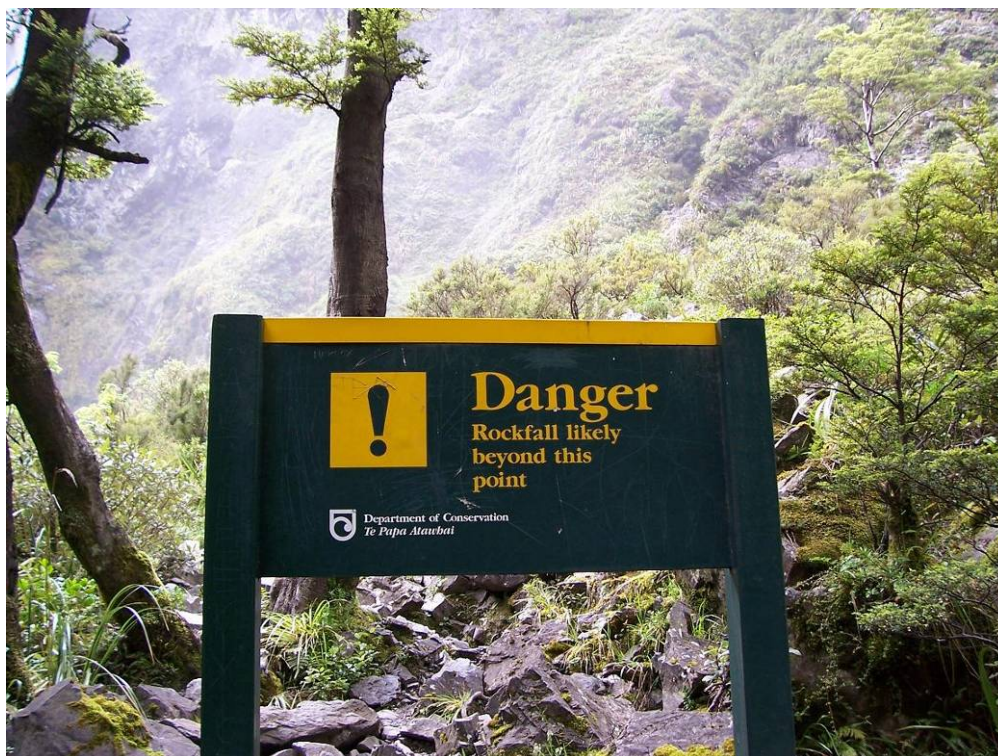
**Figure 5. 5.** A Department of Conservation rockfall warning sign located in front of a medium-sized rockfall deposit (Figure 5.6) immediately behind the Devils Punchbowl Falls lookout.

Individual rockfalls are rarely acknowledged in the literature or on Arthur's Pass mountain safety websites, but innumerable deposits have been recognised throughout the township area and are judged to be a moderate threat to the community. Although they represent a minor type of mass movement, rockfalls are potentially dangerous to individuals, particularly to trampers and climbers in the National Park. Four people have sustained injuries from rockfalls in the national park since 1998 (Kates, 2008). There are small shingle deposits on the slopes next to most of the major tributaries in the Bealey Valley, particularly along Rough Creek and Punchbowl Creek. The Department of Conservation has installed warning signs below a large rockfall deposit just upstream of the Devils Punchbowl Falls viewing deck (Figures 5.5 and 5.6), and has similar signage advising caution on the Mt. Bealey Track where rockfalls are a major issue.

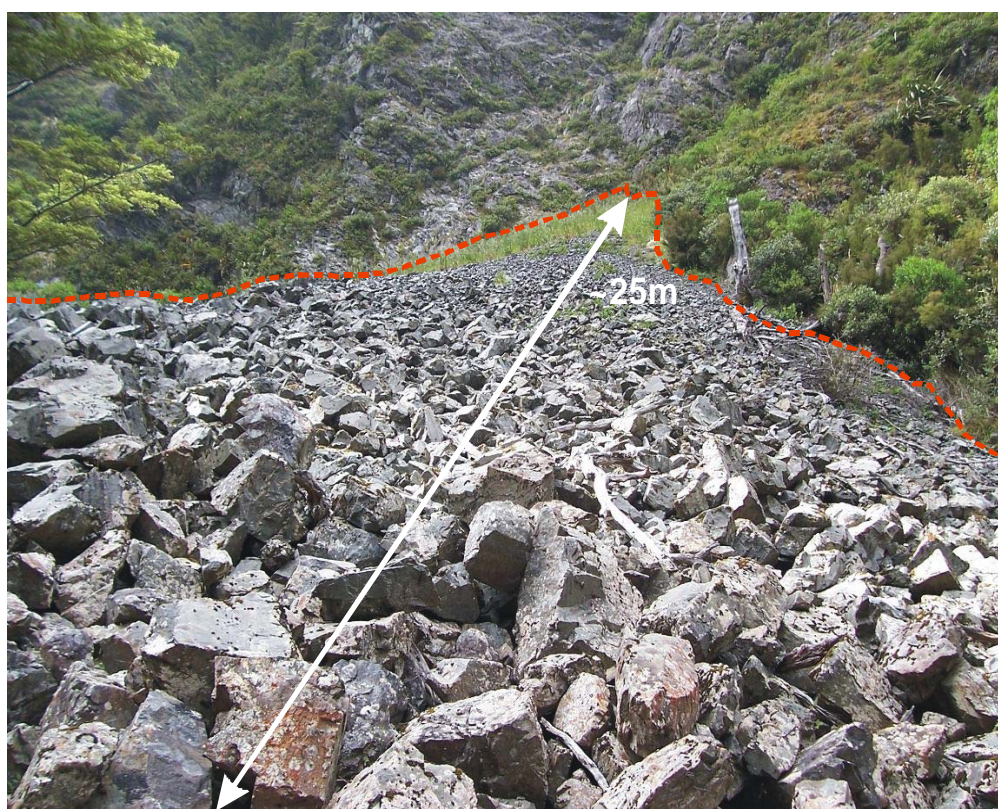
**Figure 5. 6.** A medium-sized rockfall deposit forming a debris fan behind the Devils Punchbowl Falls lookout. This particular rockfall deposit is in the vicinity of very well-used tramping tracks near the Arthur's Pass village and lies behind the Department of Conservation warning sign (Figure 5.5).

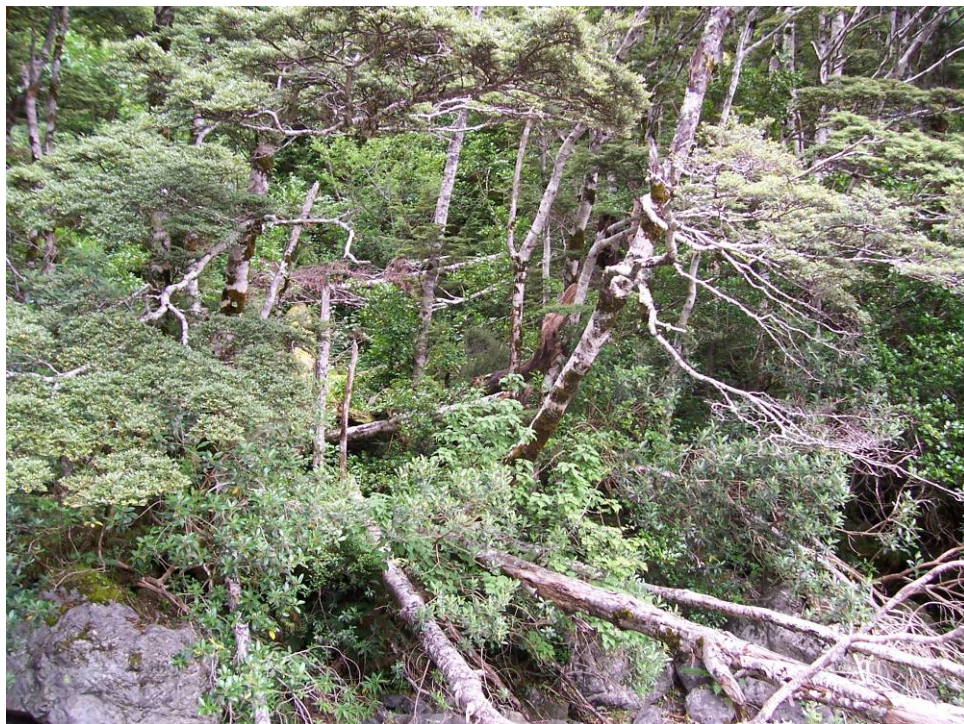
**Figure 5. 8.** A path of damaged and flattened vegetation showing the movement of a dislodged boulder down the slope into the Rough Creek tributary.

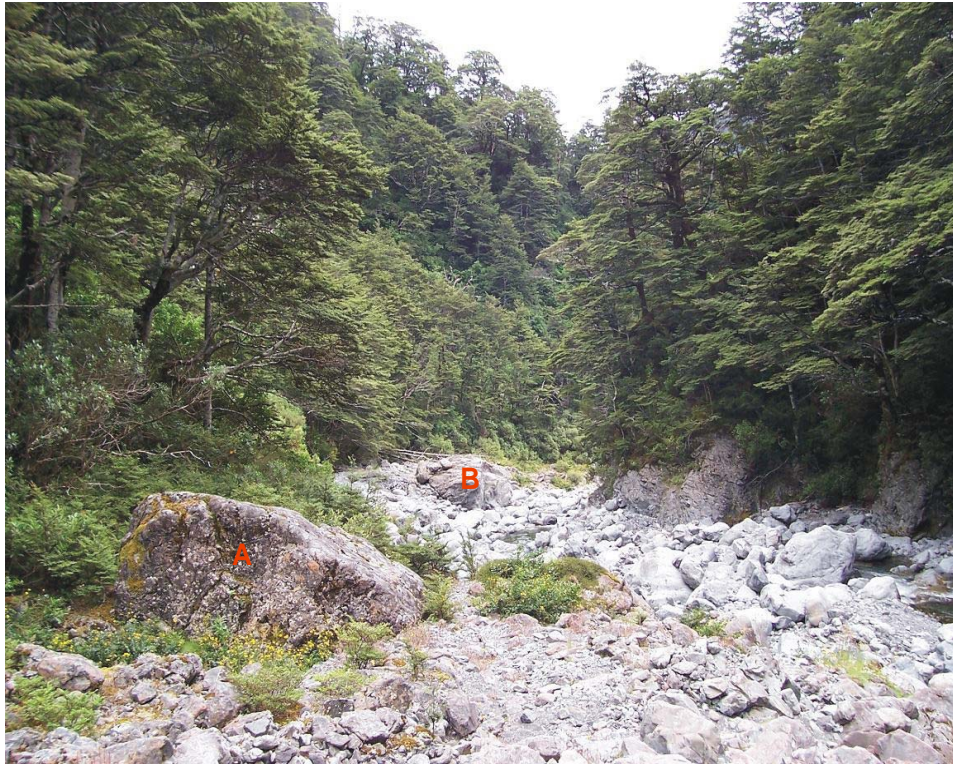
**Figure 5. 9.** Very large boulders in the Rough Creek tributary that have been dislodged from adjacent slopes and traversed through alpine vegetation to reach the creek. **A.** is approximately 2m in diameter. **B.** is 4-5m in diameter and has left a path through the vegetation on the northern slope after being dislodged during the 1994 Arthur's Pass earthquake (Figure 5.8).

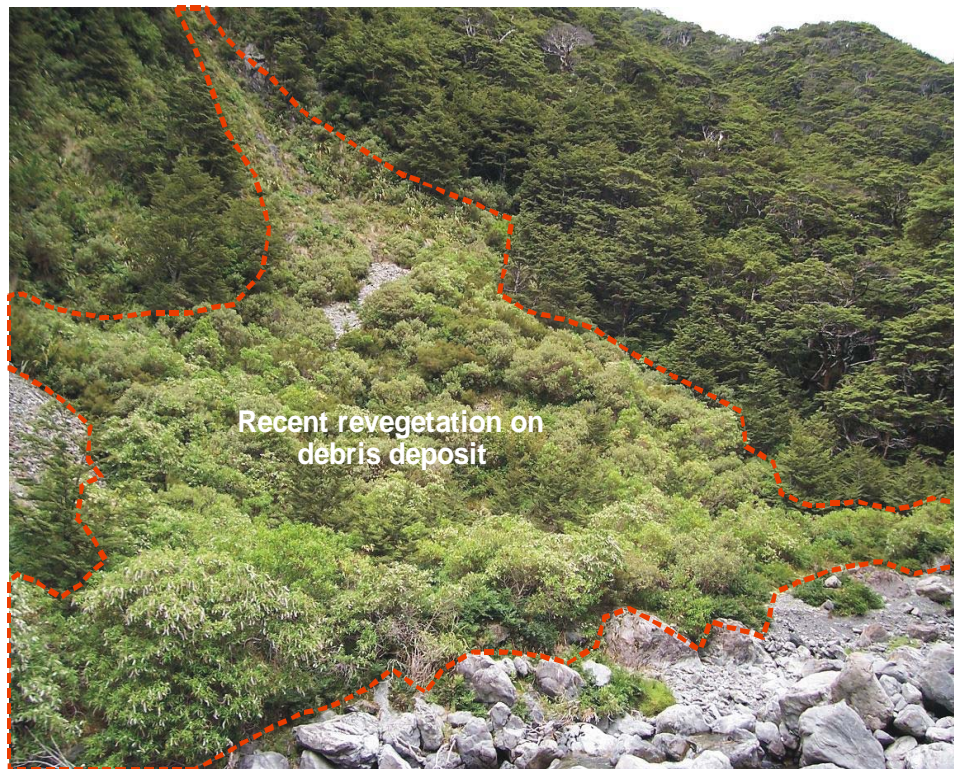
**Figure 5. 10.** A partially revegetated debris fan in the lower Rough Creek catchment. The stage of revegetation can give an indication of how recently the slope was active.

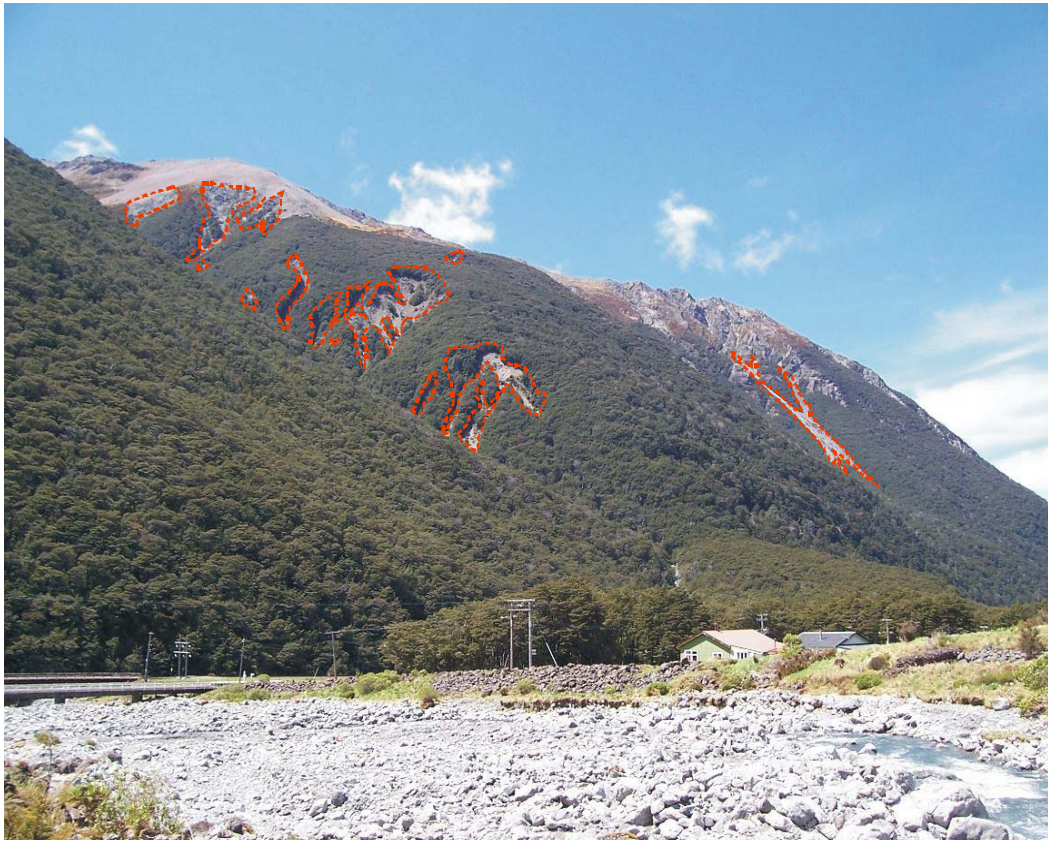
**Figure 5. 11.** Mass movement scars in the Graham Stream catchment (left) and on the slope opposite Halpin Creek (right), viewed from the Rough Creek riverbed. These particular instabilities are constantly active, and have shown only partial revegetation over the last 80 years.

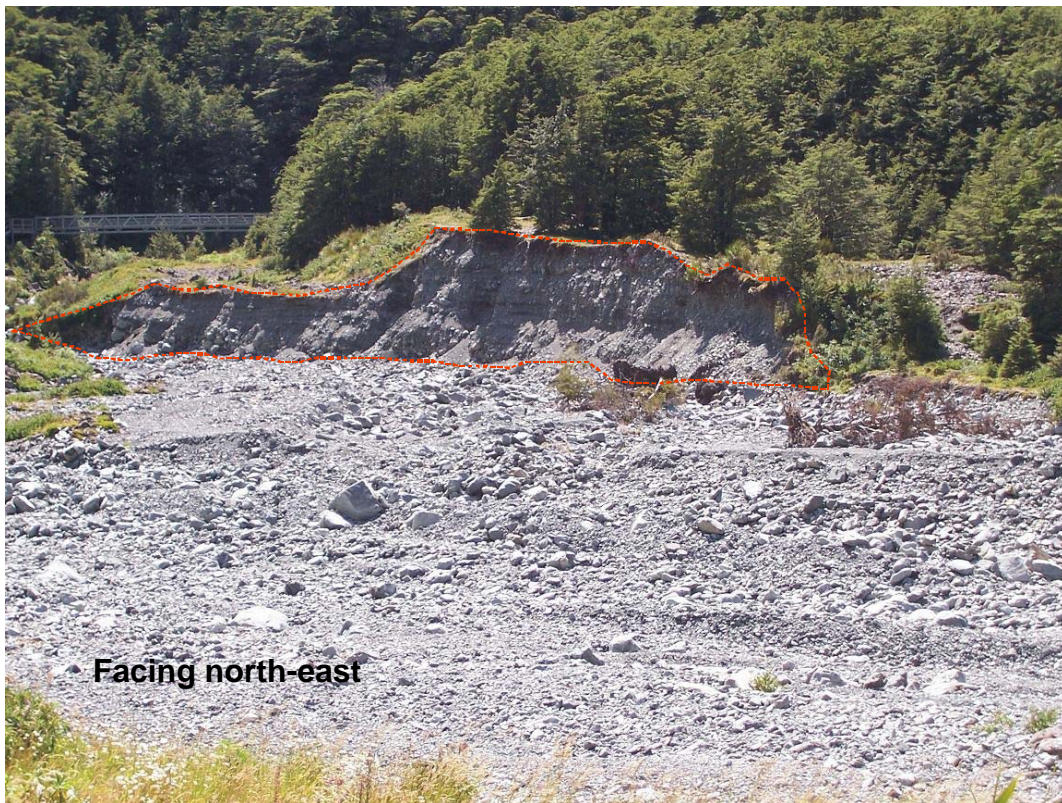
**Figure 6. 2.** Erosion and downcutting of the thick Punchbowl Creek alluvial fan at its confluence with the Bealey River.

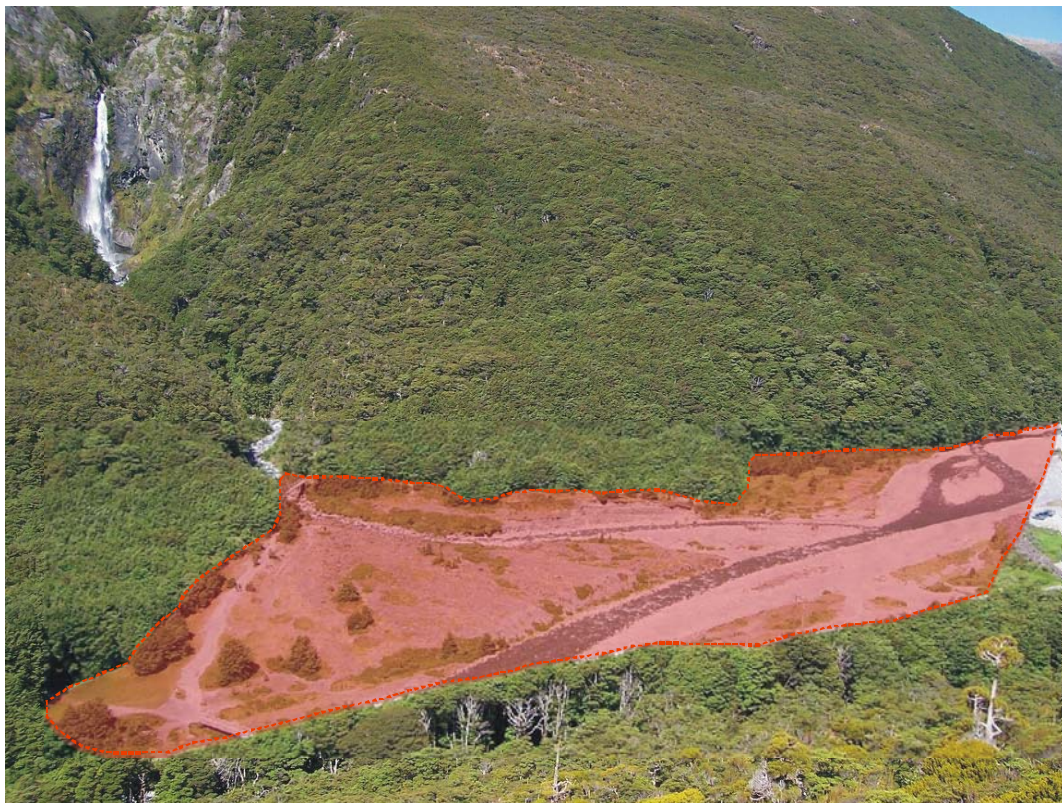
**Figure 6. 3.** The extent of the Punchbowl Creek alluvial fan showing an example of one of the largest aggradational deposits in the Bealey Valley.

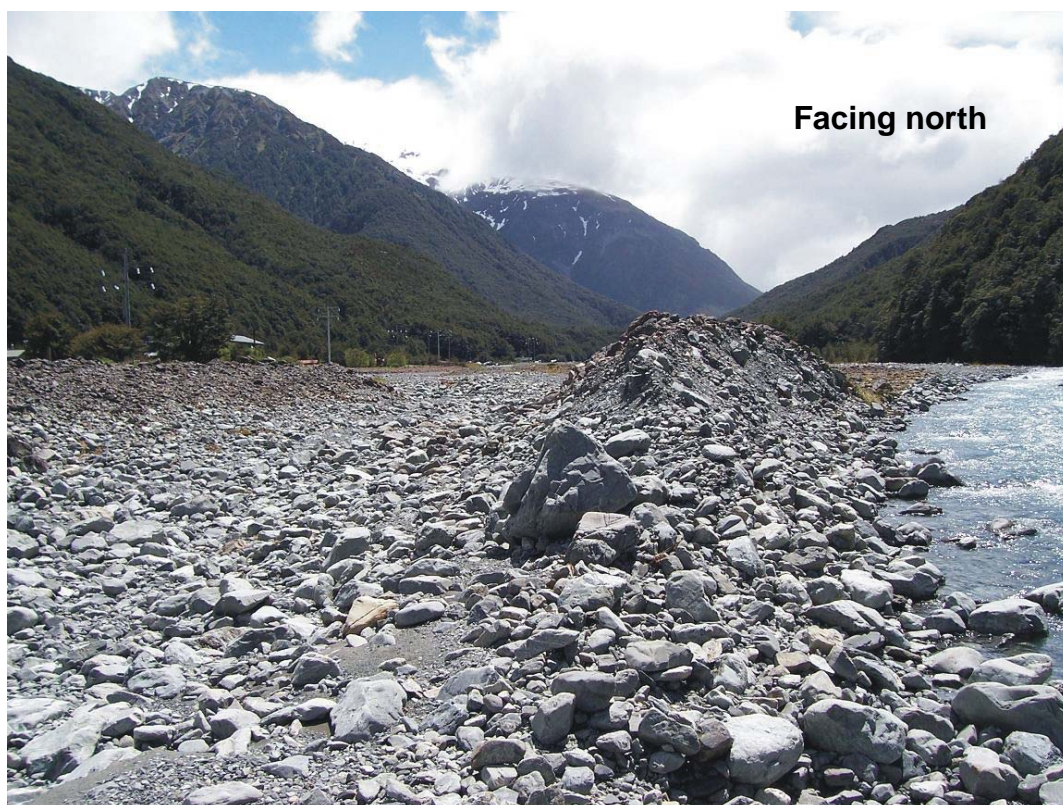
**Figure 6. 5.** A double line of 'rip-rap' stopbanks formed from natural riverbed gravel (left and centre) along the Bealey River (right) in front of Crusher Loop.

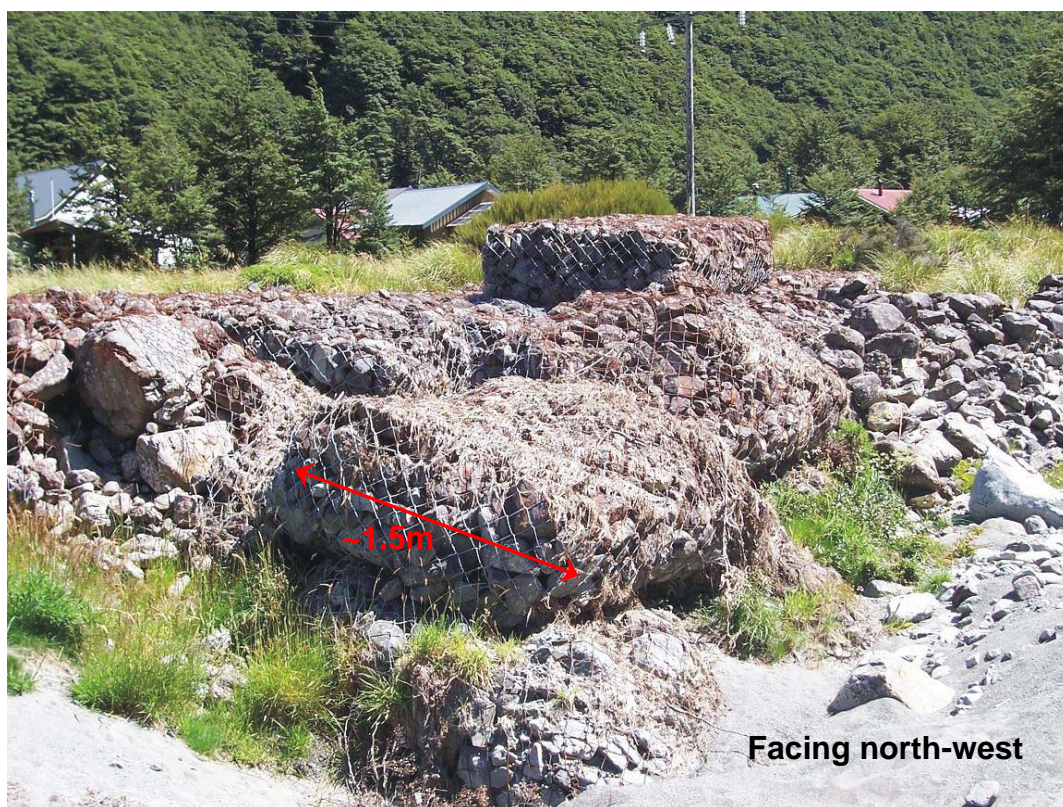
**Figure 6. 6.** Partially buried gabion stopbanks on the Bealey River bank opposite the Otira Tunnel entrance.

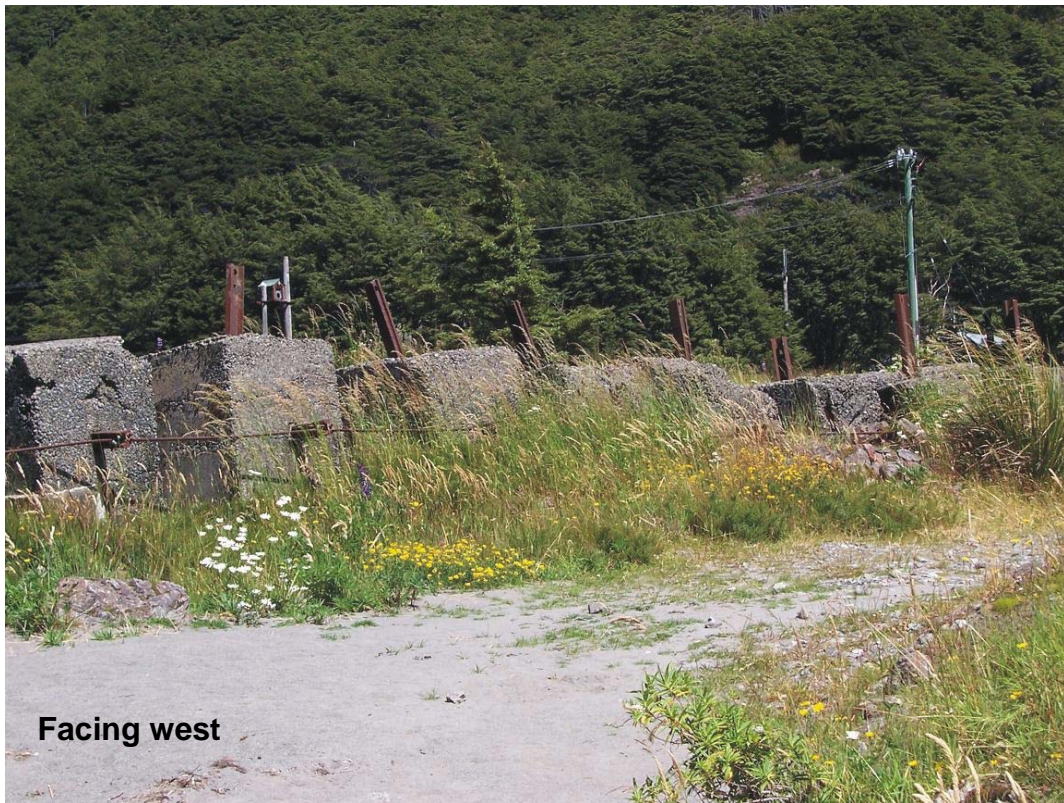
**Figure 6. 7.** Concrete retaining structures near the Avalanche Creek and Bealey River confluence protecting the railway embankment (to the left out of picture).

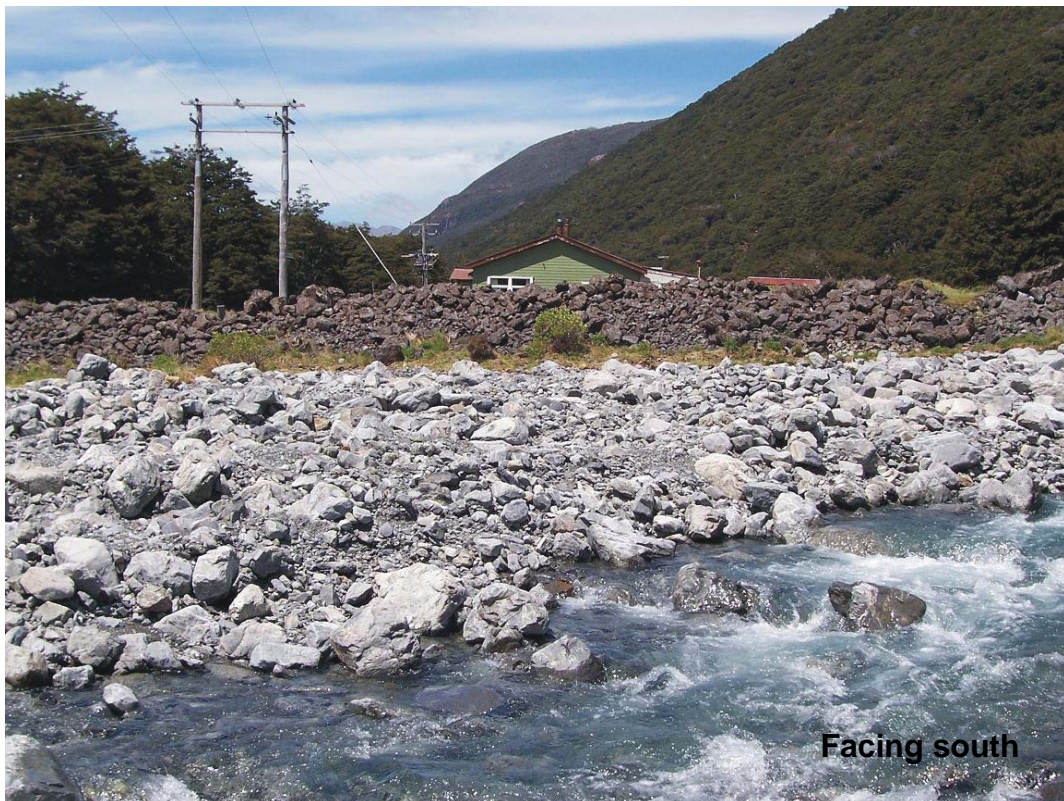
**Figure 6. 8.** A 'rip rap' stopbank along the lower south bank of Rough Creek protecting the police station and several houses on Sunshine Terrace.
